1. AGENCY USE ONLY (Leave blank)	2. REPORT DATE 25.Oct.04	3. REPORT TYPE AND DATES COVERED THESIS		
4. TITLE AND SUBTITLE VIBRATION TESTING OF THE NASA CONSTELLATION X SPECTROSCOPY X-RAY TELESCOPE REFLECTORS		5. FUNDING NUMBERS

6. AUTHOR(S) 2D LT CARLSON ANDREW J				
7. PERFORMING ORGANIZATION NAME(S) AND ADDRESS(ES) THE GEORGE WASHINGTON UNIVERSITY		8. PERFORMING ORGANIZATION REPORT NUMBER CI04-649

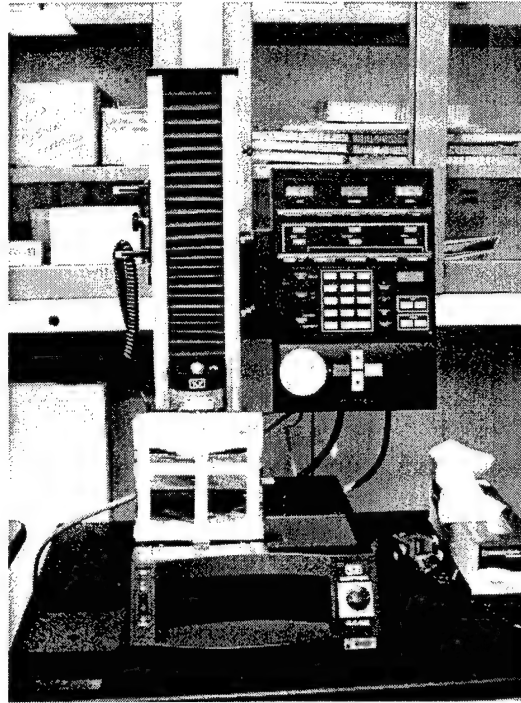
The test itself compressed the glass perpendicular to its weakest axis using an Instron 4442 Machine shown in Figure 2.13.

FIGURE 2.13: Picture of Instron machine and test setup.

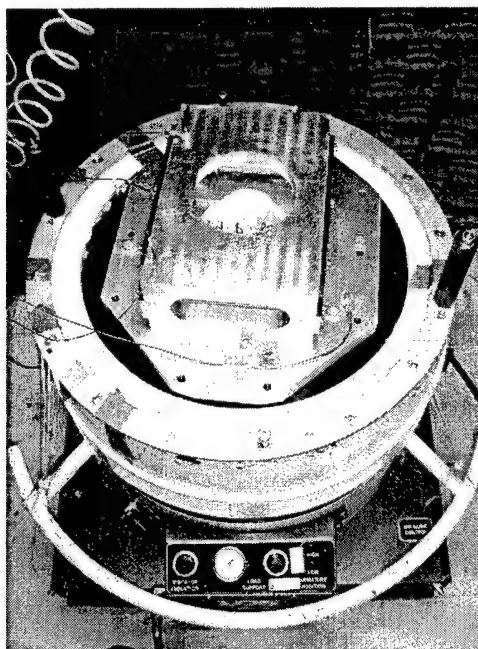
then reattached to the shaker. The bolts attaching the vibration base plate to the vibration fixture and the vibration base plate to the shaker table should be torqued to 420 in-lbs. Figure 3.10 shows the vibration fixture bolted to the base plate, which is bolted to the shaker table.

FIGURE 3.10: Test article mounted on the shaker table.
